Product Change Notification - SYST-12XLUL037

ERRATA - PIC32MZ Graphics (DA) Family Silicon Errata and Data Sheet Clarification

PIC32MZ Graphics (DA) Family Silicon Errata and Data Sheet Clarification

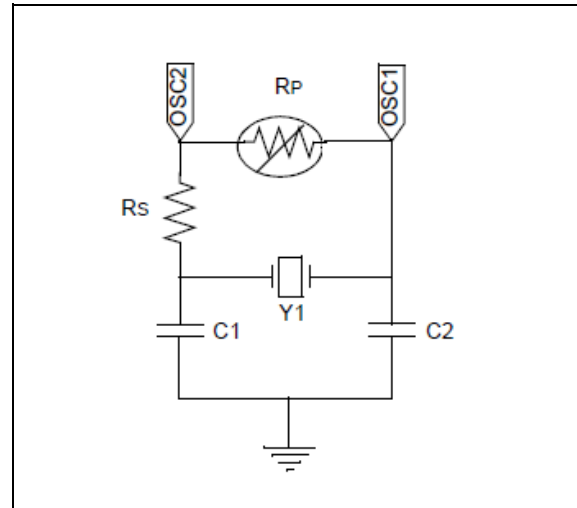
FIGURE 1: Posc CRYSTAL CIRCUIT

The POSC has been tested in a normal power-up sequence and supports specific crystal operation.

The Primary Oscillator (POSC) has been characterized to operate at 8 MHz and 12 MHz when the circuit shown in Figure 1 is implemented, and the operating conditions listed in Table 3 are met.

Crystal Frequency (See Note 1)	Series Resistor Rs	Posc Gain Setting POSCGAIN<1:0> (DEVCFG0<20:19>)	Posc Boost Setting POSCBOOST (DEVCFG0<21>)
8 MHz	2 kΩ	'0b00 (GAIN_0)	'0b1
12 MHz	1 kΩ	'0b00 (GAIN_0)	'0b1

2: A parallel register (Rp) should not be used to increase the gain of the Posc.

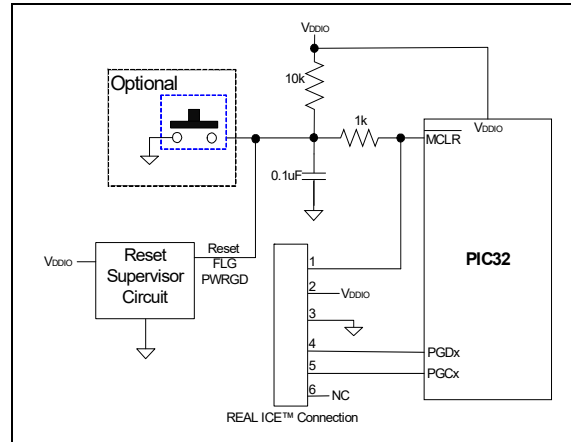
FIGURE 2: EXTERNAL RESET CIRCUIT

A system Reset is not generated on a BOR event ($V_{PORIO} < V_{DDIO} < V_{BORIO}$). This will stop system clocks with all the I/O pin functions frozen in the present state until either V_{DDIO} falls to V_{PORIO} or $V_{DDIO} > V_{BORIO}$.

Reset device using a \overline{MCLR} pin through an external reset supervisor/monitor is shown in Figure 2. Set the SMCLR (DEVCFG2<15>) configuration bit to '0', which makes the \overline{MCLR} to act as a POR Reset instead of a normal system reset.

- Minimum Reset trip voltage of the external supervisor should be $V_{BORIO} (Max) + 0.5V$.
- The external reset supervisor/LDO output going to \overline{MCLR} should have an open drain output to not interfere with the MPLAB programming/debug tools.

When this work around is implemented, the minimum V_{DDIO} operating voltage of the application needs to be above the reset supervisor maximum trip voltage + 0.2V, where 0.2V compensates for variation in the external reset supervisor voltage.
