Product Change Notification - SYST-08UUHO160

ERRATA - dsPIC33CH128MP508 Family Silicon Errata and Datasheet Clarification

dsPIC33CH128MP508 Family Silicon Errata and Data Sheet Clarification

The dsPIC33CH128MP508 family devices that you have received conform functionally to the current Device Data Sheet (DS70005319D), except for the anomalies described in this document.

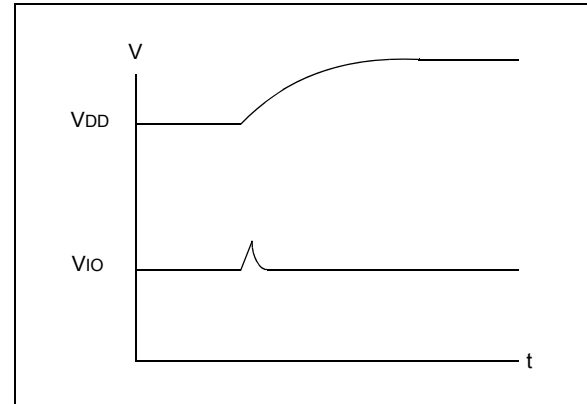
FIGURE 1: I/O RAMP

During a fast device power-up, when the V_{DD} ramp is less than 4 mS, the I/O pins may drive up to 100 μ A current for a duration of up to 10 μ S (Figure 1).

Example applications affected may include complementary power switches, where a transient current shoot-through might occur.

1. Slow down the V_{DD} ramp time (greater than 4 mS for V_{DD} to ramp 0V to 3.3V).
2. Ensure the circuitry that is connected to the pins can endure this pulse.

High-voltage applications with complementary switches should power the high-voltage 200 μ Sec later than powering the dsPIC[®] device to avoid the current shoot-through. This behavior is specific to each device and not affected by aging.
